RE: Progress report for October 2007 activities - Hecla Mining Company Apex Site (EPA ID No. UT982589848, Docket No. RCRA-8-99-06)

SUBJECT: Progress Report No. 42 for period ending October 31, 2007; Pond 2 Final Closure - Apex Site, Washington County, Utah

TO: Paul Glader (Hecla Mining Company)
FROM: Doug Gibbs (Monster Engineering Inc.)
DATE: 10/1/07
SUBJECT: **Surface Monument Survey Data Review – Apex Site**

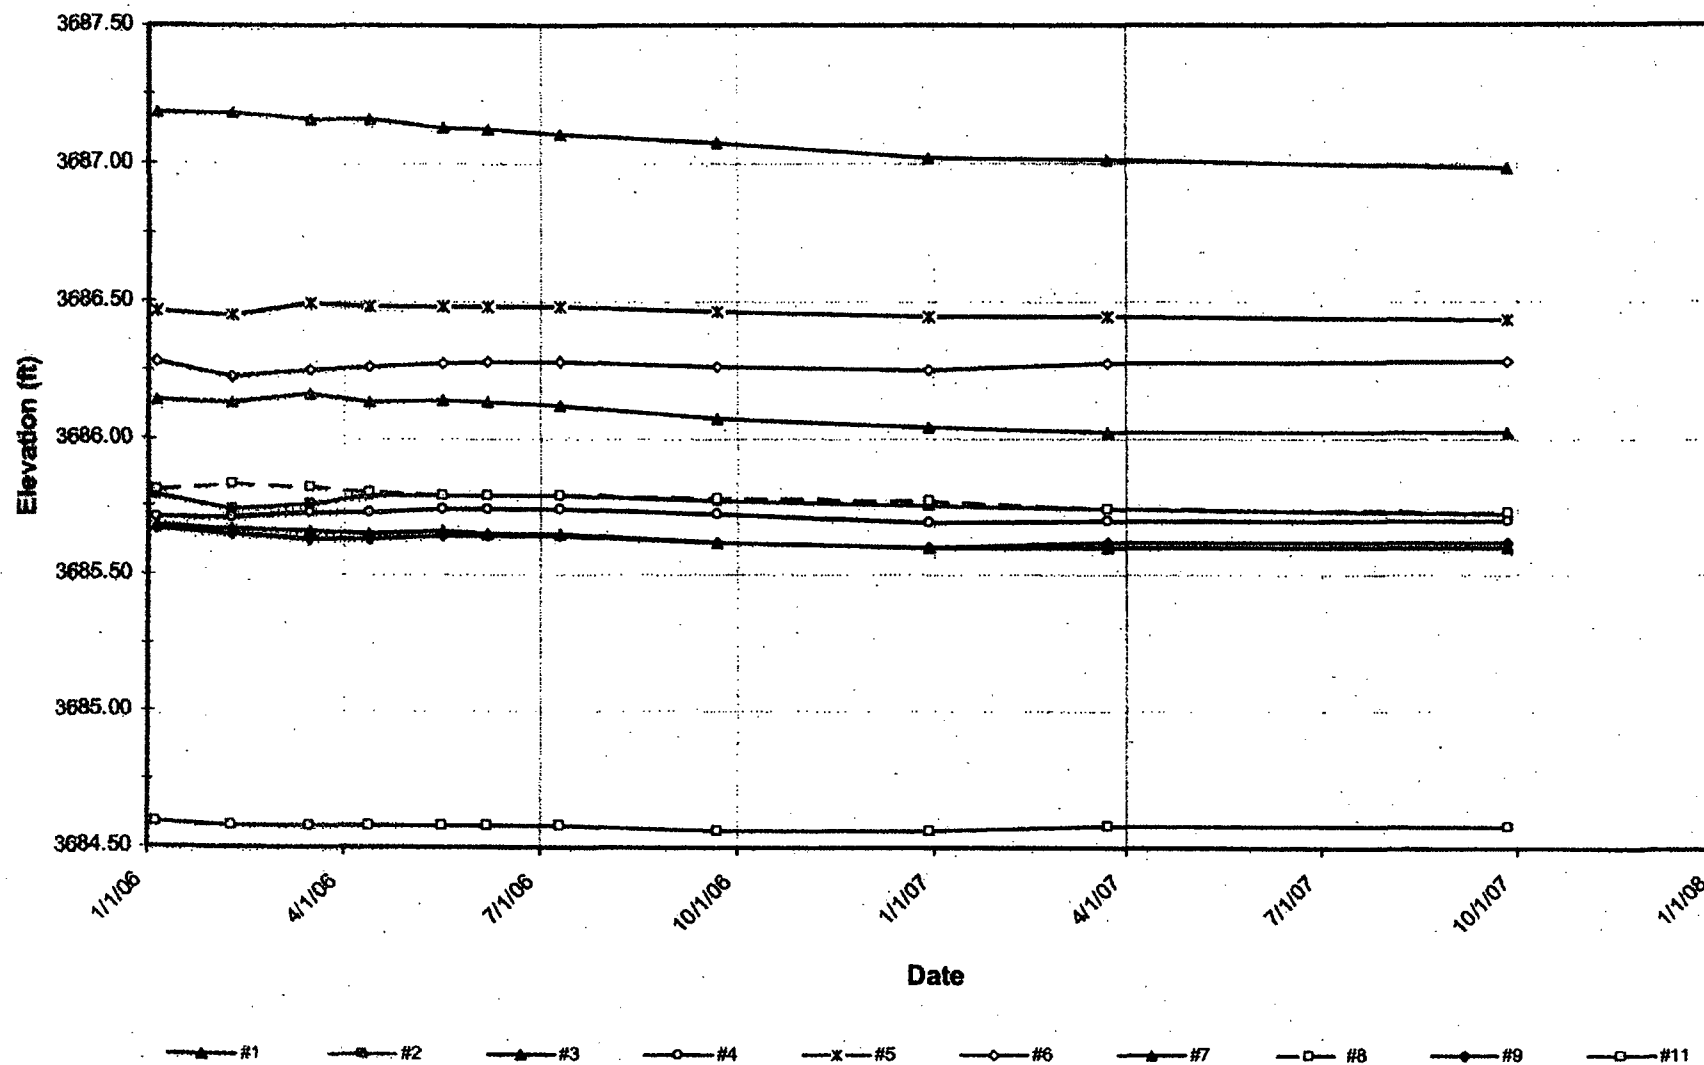
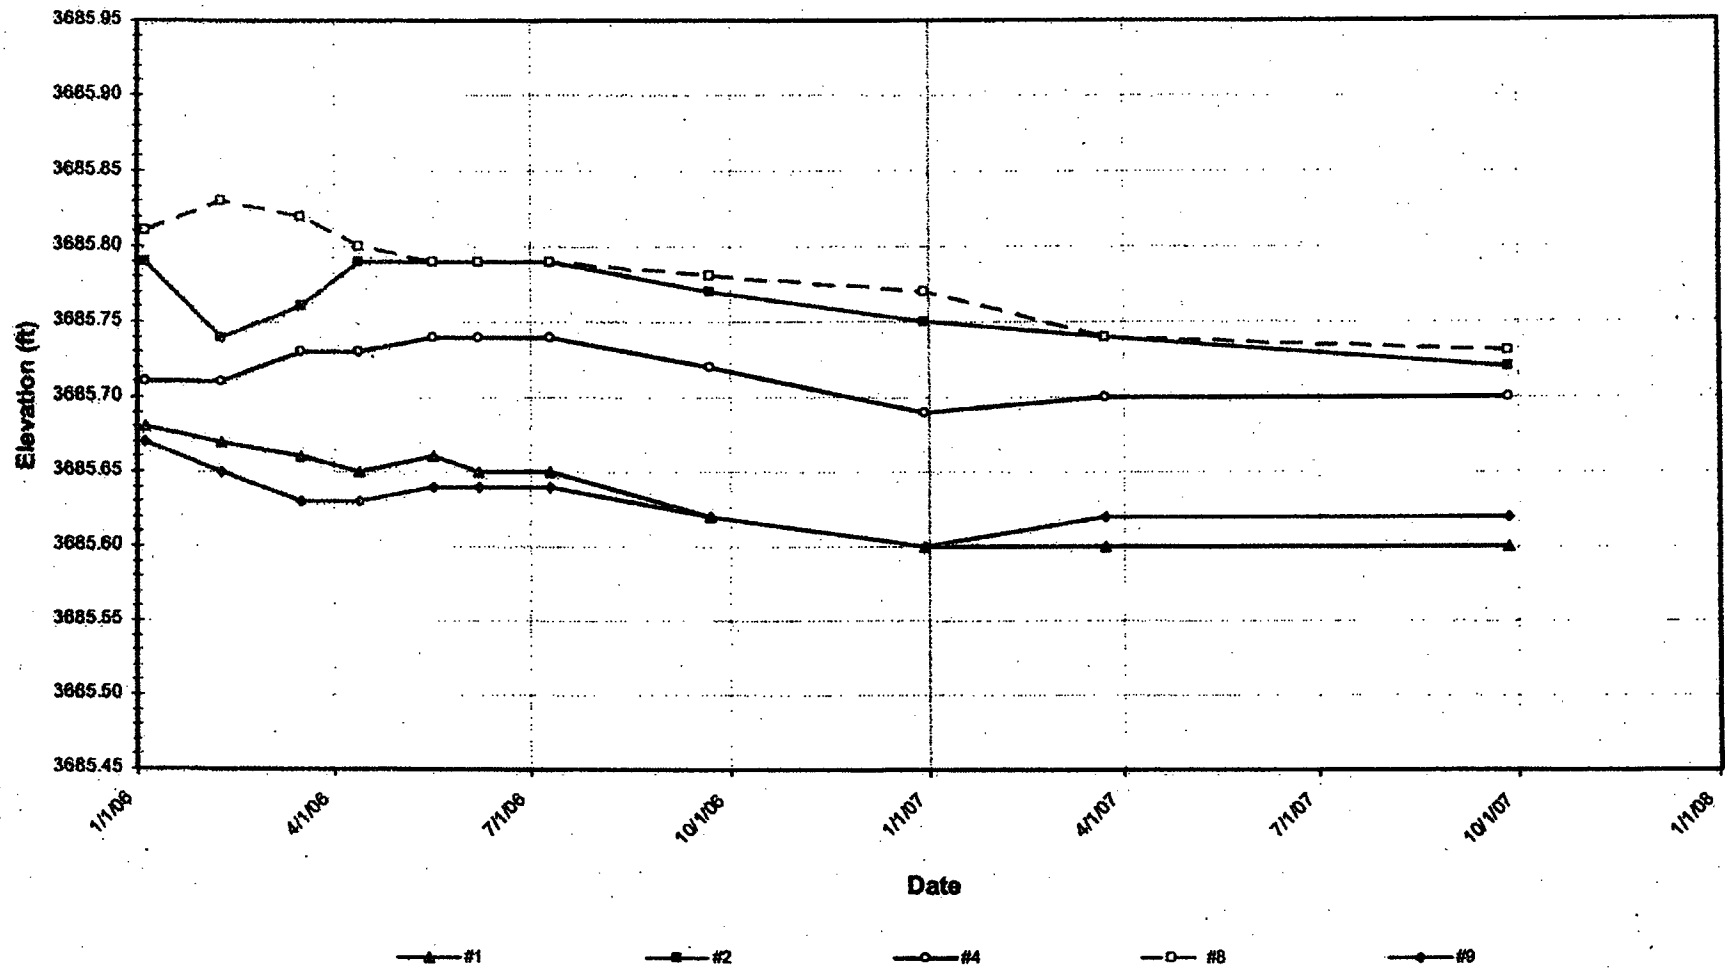
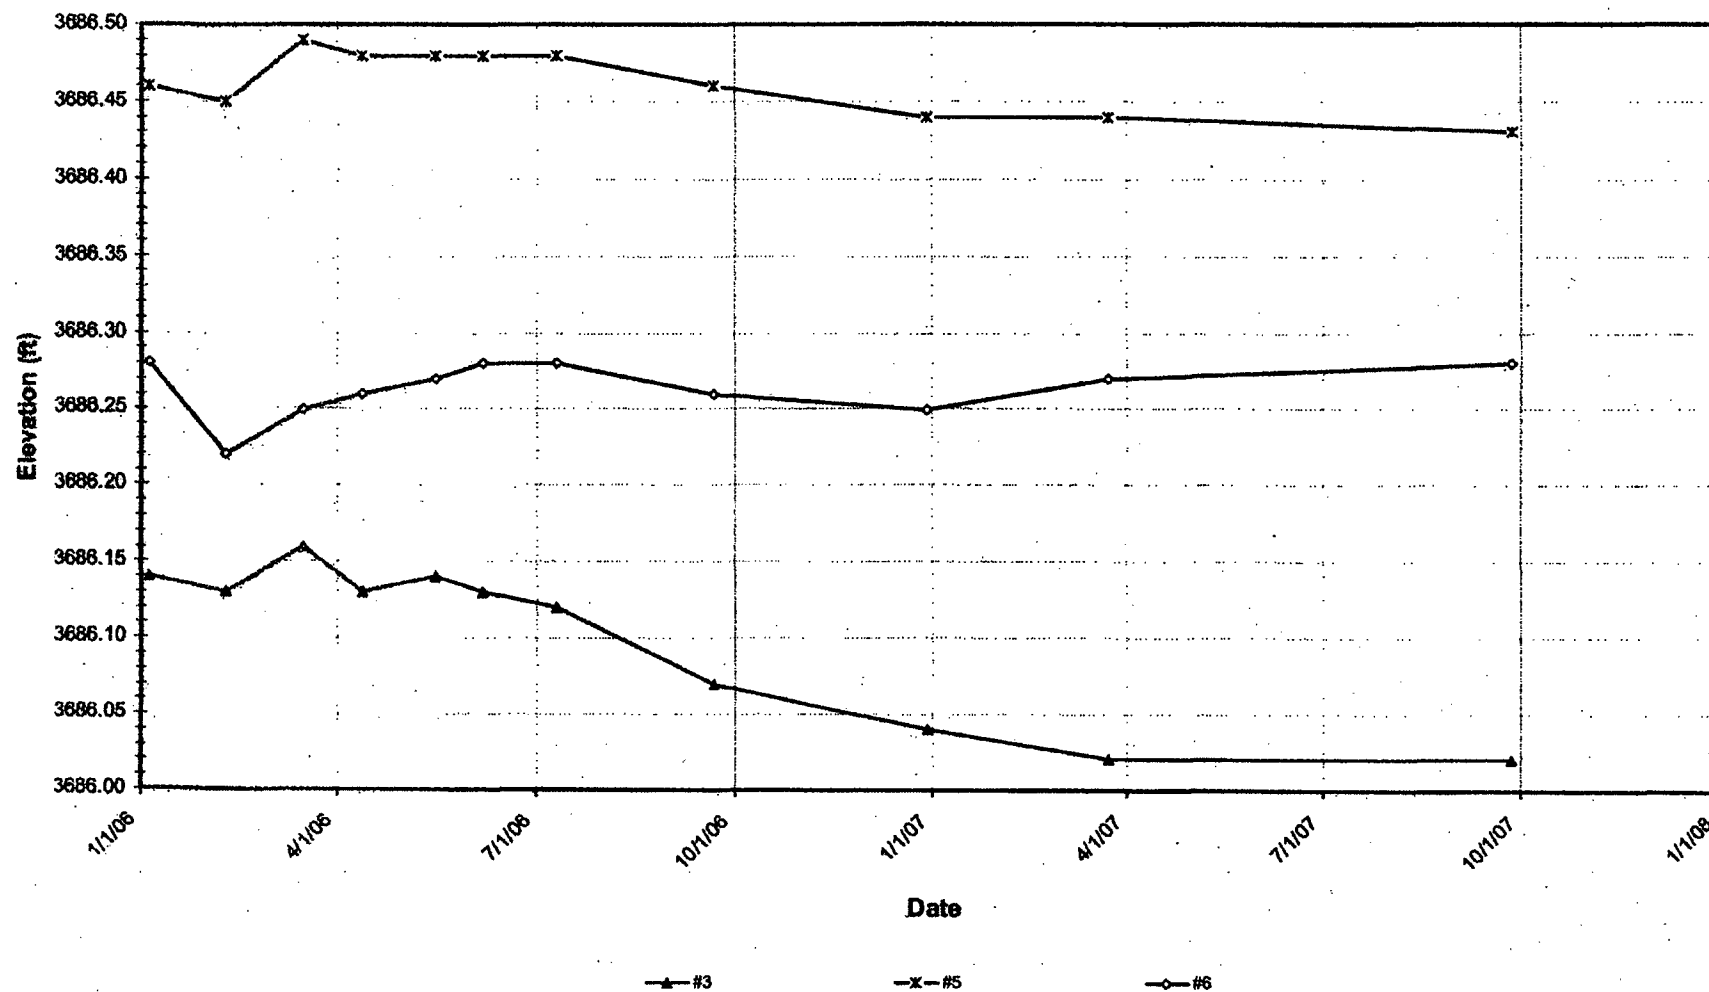
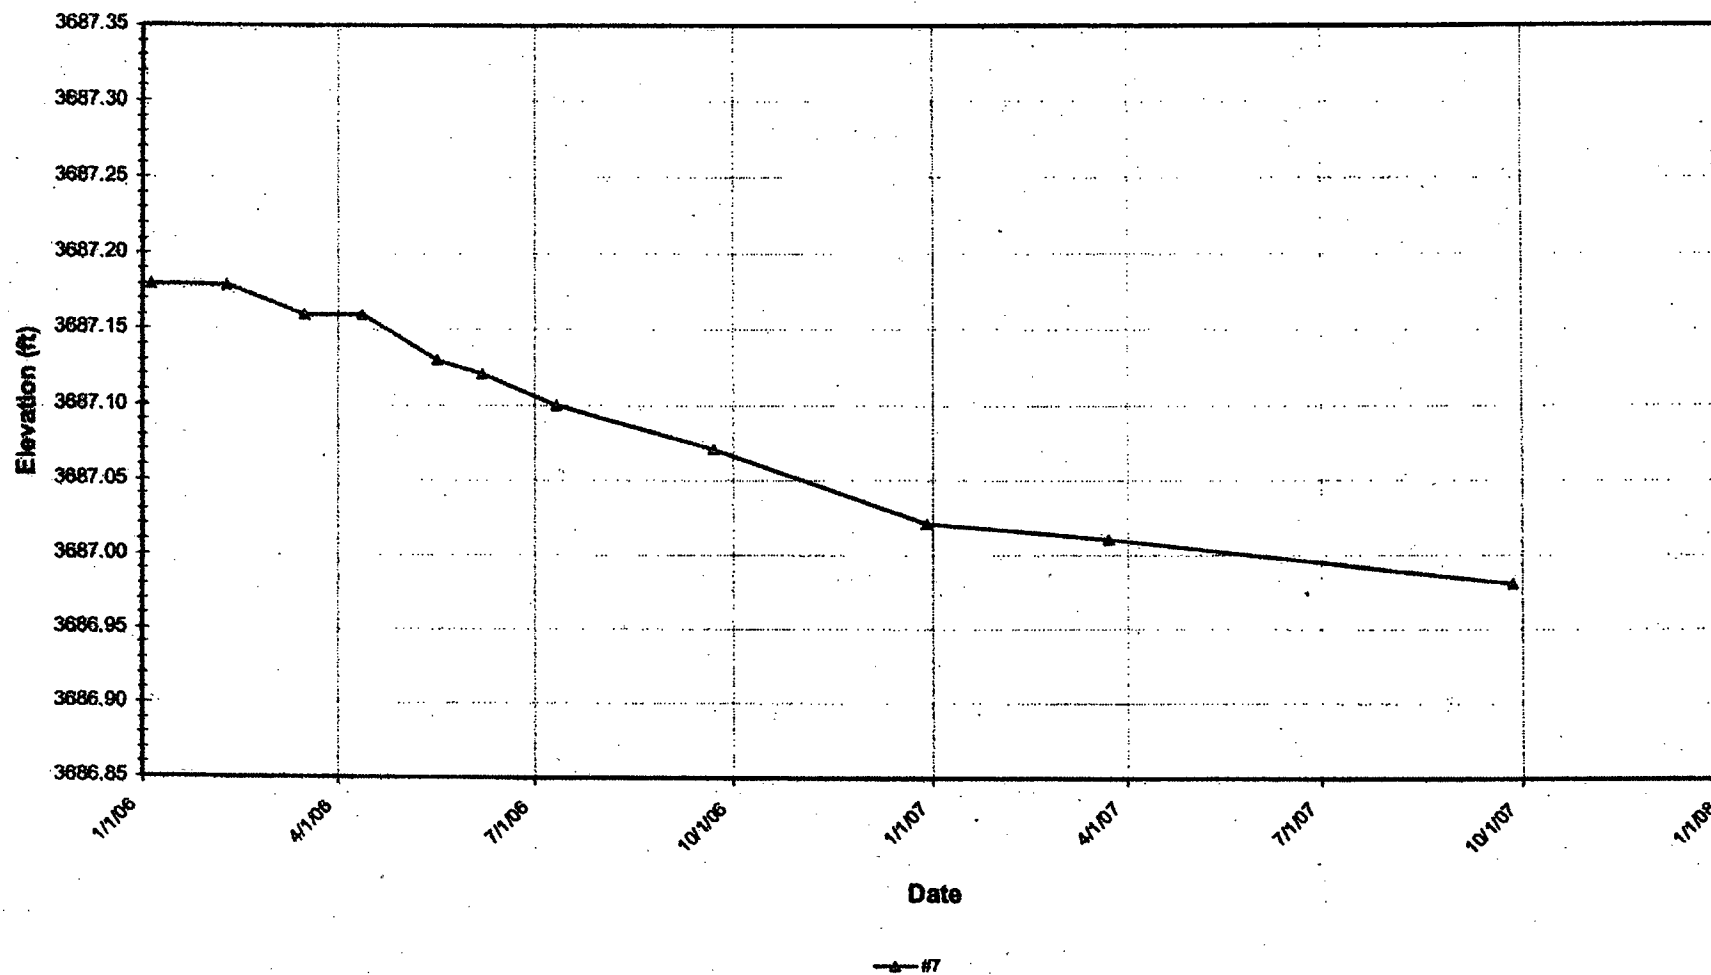
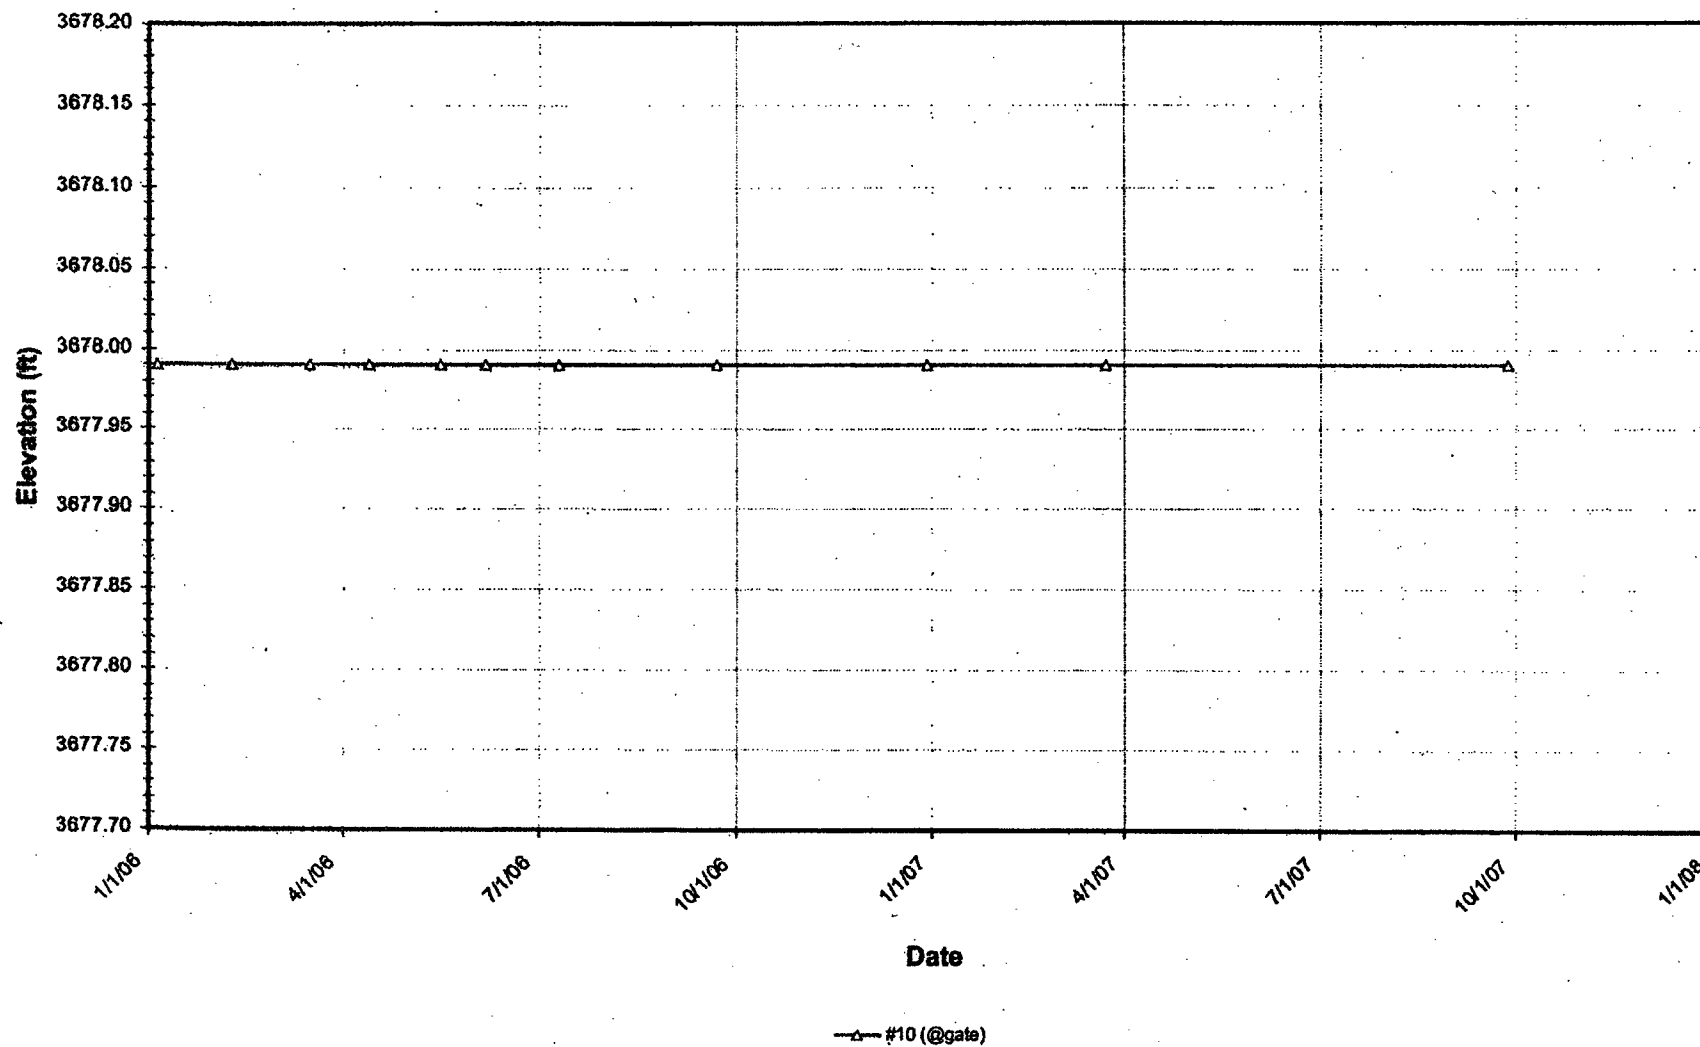
In summary the data shows that roughly the northern half of the impoundment has settled between 0.05 and 0.2 feet. The southern half of the impoundment has remained very consistent with little to no settlement. The largest measured settlement is, as expected, near the center of the impoundment (#7, -0.2 feet). Slightly greater settlement in and nearer the center of the impoundment is to be expected as significant quantities of fill were placed in this area during construction. Additionally, greater settlement should be expected on the northern half of the impoundment based on the locations and methods utilized to place the original cover materials (prior to final reclamation activities). According to Chris Gypton and Alan Wilson, cover materials were initially placed in the southwest corner and generally moved across the impoundment towards the northeast corner. This created a mud wave of unconsolidated waste which moved towards this corner, and eventually a thicker deposit of unconsolidated waste materials.

There appear to be no concerns to date with settlement. As expected with long-term consolidation, the data shows that settlement rates are decreasing over time. Consolidation of waste materials and/or final reclamation liner materials appears to be very minimal and decreasing. Additionally, it is highly unlikely that any liquids are leaving the impoundment.

Based on data collected to date, MEI recommends that Hecla continue with their current plan and collect elevation data quarterly. Please call or email me if you have any questions concerning this review.

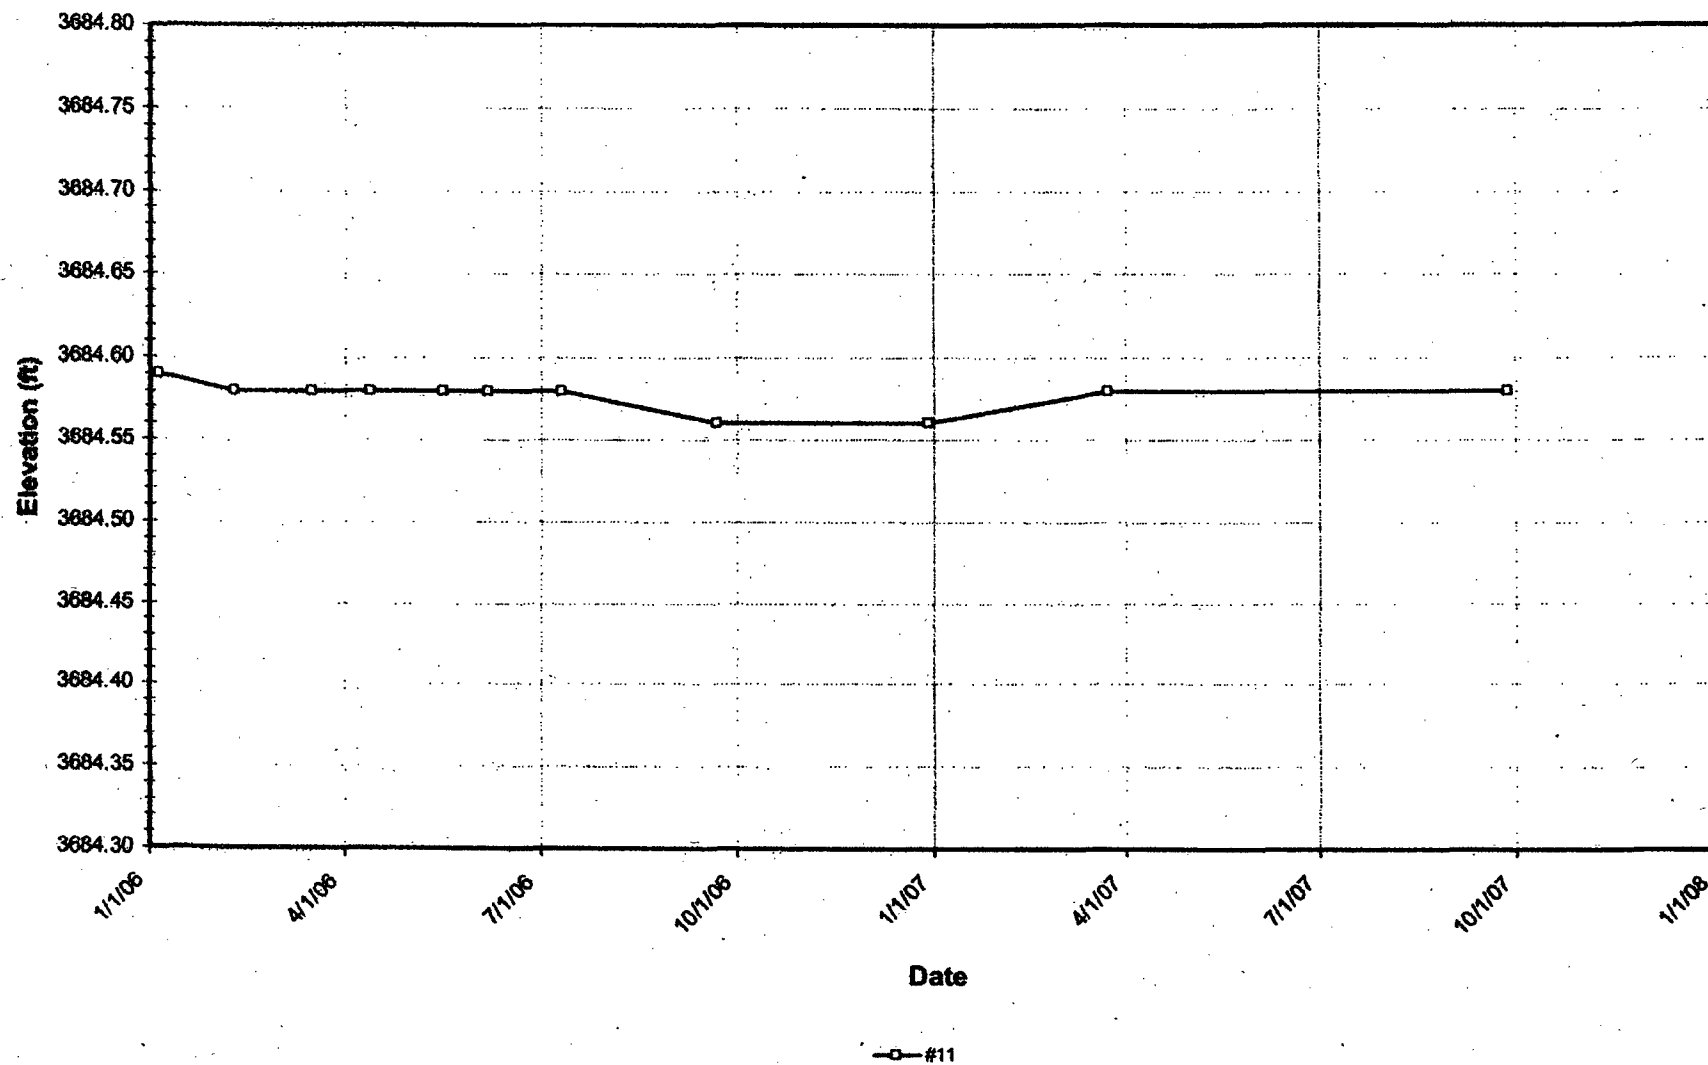
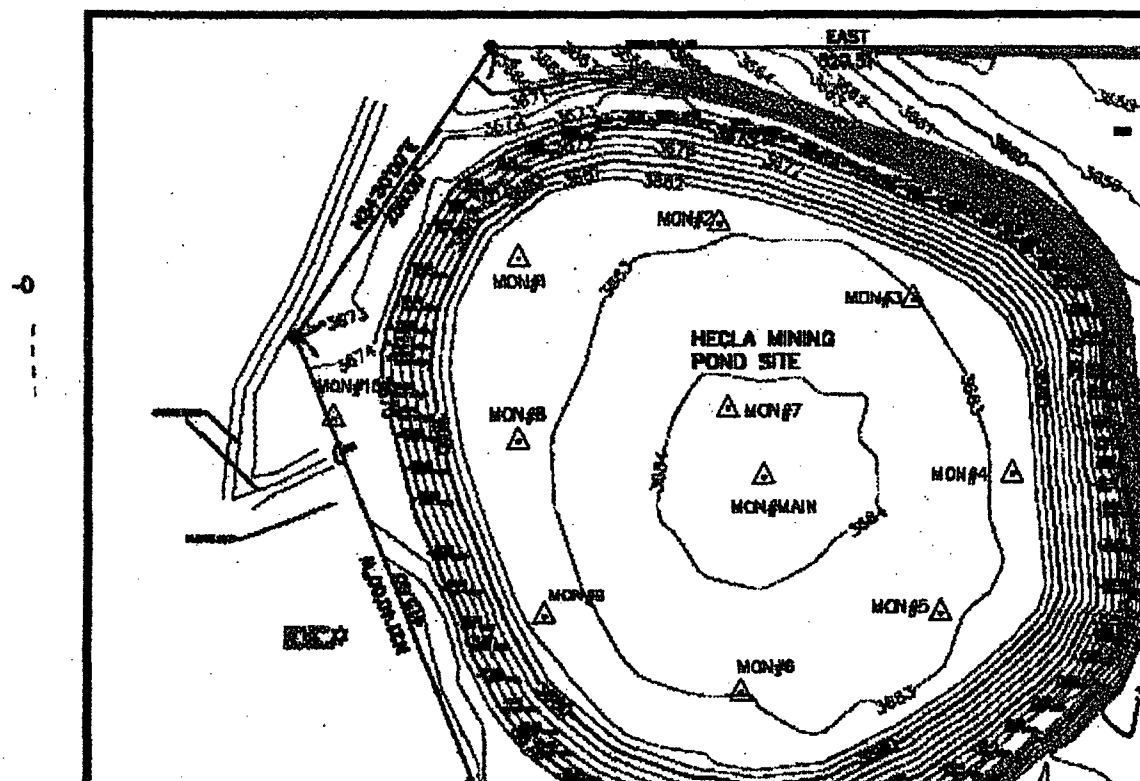
All elevation data provided by Alpha Engineering is presented graphically on the following pages. The first graph shows all monuments (except #10 the baseline point) on a scale that allows all data to be compared. The next five graphs have expanded and equivalent "Y" axes scales in order to more clearly show elevation changes, and for ease of comparison between graphs. A monument location map (provided by Alpha Engineering) is attached on the last page of this document. Included on this map are contours showing approximate total settlement of the top surface since installation of the monuments.
